AIRCRAFT GROUND-FLOTATION INVESTIGATION

PART III. DATA REPORT ON TEST SECTION 2

TECHNICAL REPORT AFFDL-TR-66-43, PART III

APRIL 1966

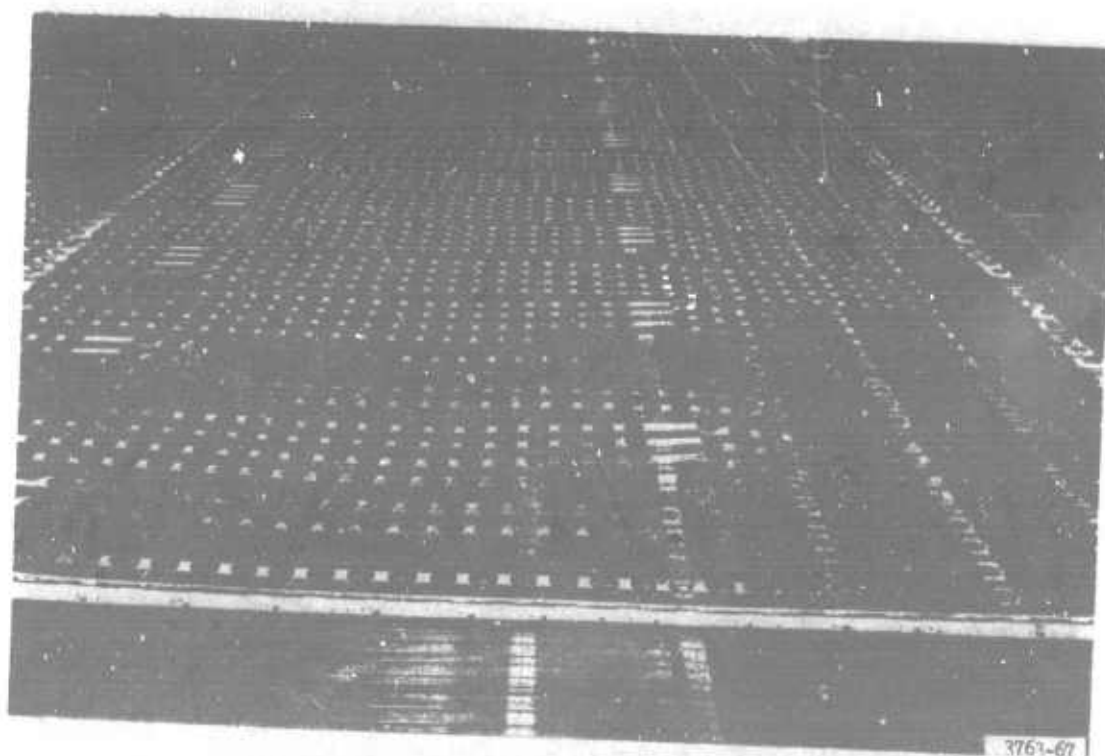
Figure 9. Lane 3, item 2, at 122 coverages
(2 postfailure coverages)

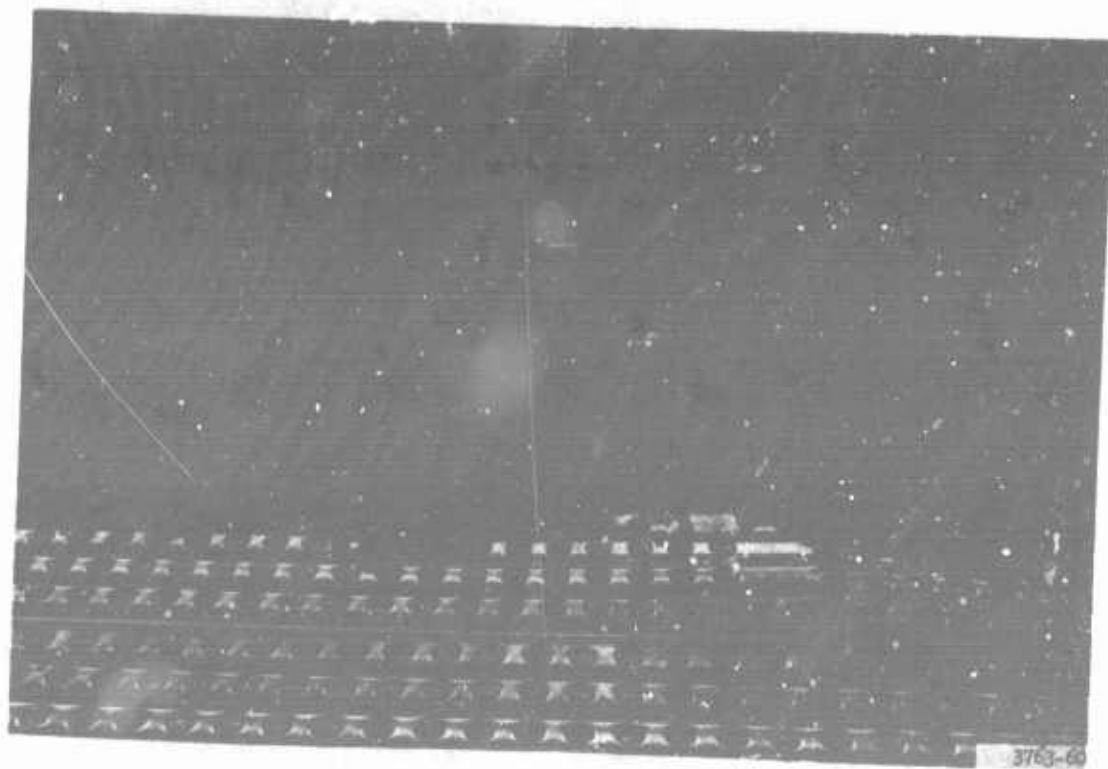
Item 3. Item 3 is shown in **Figure 12** prior to trafficking. Ruts had begun to develop by 20 coverages (**Figure 13**), and at 60 coverages the ruts were severe enough to constitute failure of the item (**Figure 14**).

Figure 13. Lane 3, item 3; transverse straightedge shows roughness at 20 coverages
